# *SEM Diaries - 14*

## *What's in a Filament?*

Jeremy Poole

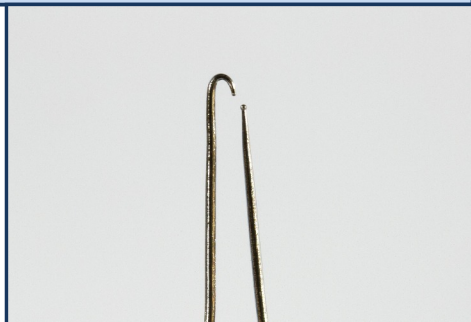
Fig. 2: Detail of Blown Tip of Filament

Normally when a filament blows there is a definite breakage visible to the naked eye, near the tip. This is illustrated in Figure 2. When I removed my favourite filament I could see no break at all. I checked for continuity, which confirmed an open circuit, and I eventually determined that this arose because the tungsten wire had come detached from one of the legs to which it is secured. This was sufficiently unusual to me that I drew it to the attention of my filament supplier, who immediately supplied two free filaments on the condition I returned the damaged one for him to send back to the manufacturer. Bargain!

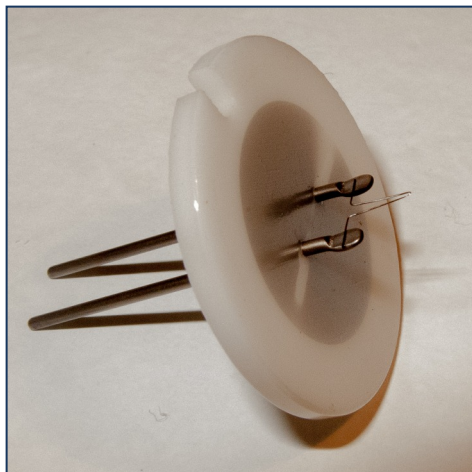
Fig. 4: A complete (but blown!) filament assembly, showing tungsten deposit on the insulator.

blown, and the dark matter on the top of the base is evaporated tungsten.

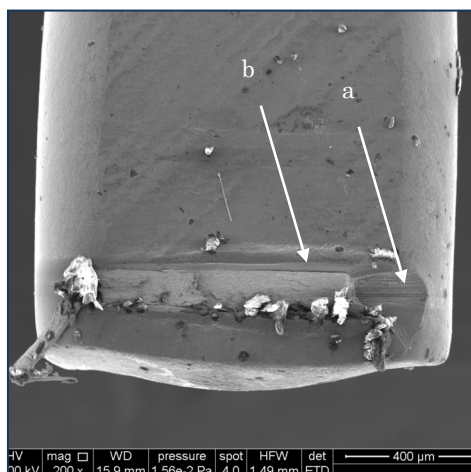
Figure 6 shows one of the feet of the filament I damaged. (This is inverted compared to the orientation of Figure 1.) What can be seen is tungsten wire resting in a groove on one of the feet. At the right hand end it would appear that a piece of

tungsten wire has been broken off (a), and this is consistent with the condition of the tungsten loop seen under the light microscope. There is a gap between the wire and the groove in the middle (b), and nowhere is it clear how the wire is retained in the groove. The light toned particles are charged, so must be non-conducting, and could be from the polystyrene packing in which the filaments are supplied.

Fig. 6: One foot of damaged filament, with features mentioned in text indicated.

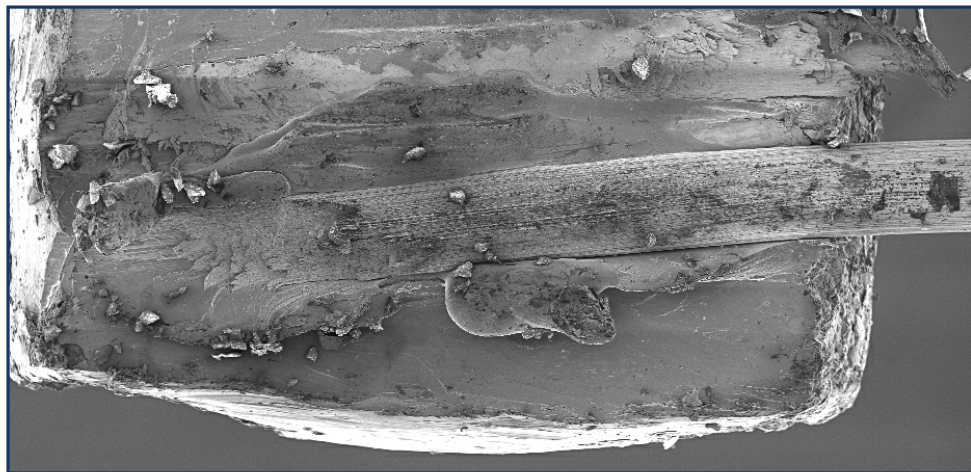
Fig. 7: Detail of the tungsten wire to foot bond on a new filament.

The filament of Figure 6 was brand new, but I had mishandled it, so I decided to look at a new filament straight from the packing. The result of this is shown, enlarged, in Figure 7. Key features to note are: the tungsten wire of the filament projects out to the right; there is a clean boundary between the tungsten and the groove in the foot along much of the right half of the foot; there appears to be tearing of the tungsten wire at the left hand end, as if it had been separated from the rest of the reel of metal using the properties of metal fatigue (bending a wire back and forwards until it breaks).

It is not clear exactly how the tungsten wire is secured in the slot. The area around the broken end of the tungsten does show some attempt at what might be welding, as does the blob underneath the tungsten to the right, although that does not actually seem to have bonded. If this were a wire on a printed circuit board I would say that the soldered joint was exceedingly "dry"!

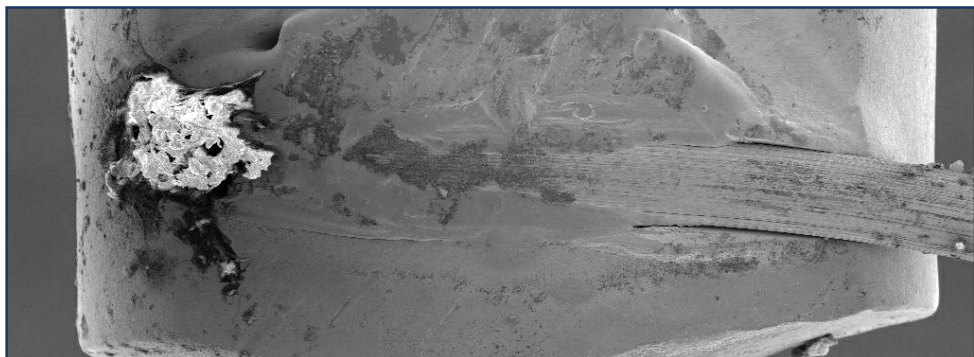
Fig. 8: Foot of a different new filament showing similar manufacturing "artefacts".

I decided to look at a different unused filament, and the image is shown in Figure 8. This shows similar construction and similar issues, although the area of "successful" weld is greater. Of interest in this

micrograph is the charged non-metallic material to the left of the image. Looking at it under a stereo microscope I determined that this is white material, in the cavity where the tungsten wire has been broken off during manufacture. I have not attempted to probe it with a tool, but it does not appear to resemble the white polystyrene packing material. Perhaps it is some sort of flux?
