# *SEM Diaries - 14*

## *What's in a Filament?*

Jeremy Poole

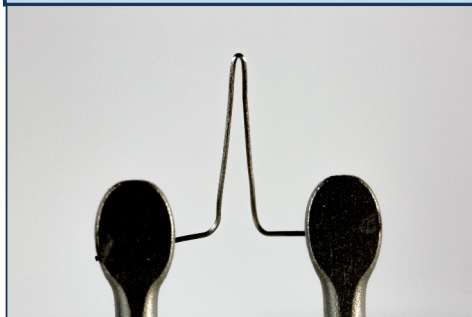
Fig. 1: New Tungsten Filament for my SEM

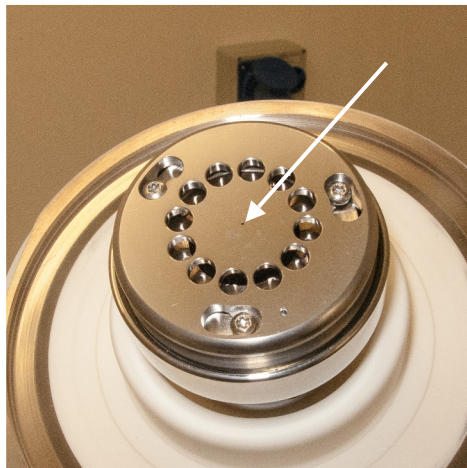
Replacing a tungsten filament when it reaches the end of its life - it blows in the same way as a conventional light bulb does - is not straightforward. The filament resides within a closed cylinder known as the Wehnelt cap (Figure 3). This has a fine hole in the end behind which the filament resides. The filament must be aligned accurately with the hole, not only axially, but also the distance of the filament tip behind the front of the hole (0.25 mm) must be set correctly.

When the filament blows, molten tungsten is sputtered around the inside of the end of the Wehnelt cap. This may sometimes obstruct the hole in the cap end or, worse,

Fig. 3: View of the Wehnelt cap in situ on my SEM (with the column top hinged back). Note the very small central hole (arrowed), hiding the tip of the filament.

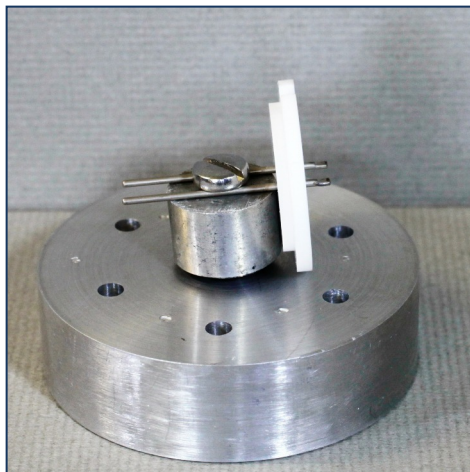
So, I have a filament to look at, but how do I mount it in the SEM? The solution I arrived at was very simple. I took a length of 1/2" diameter aluminium rod, about 1/2" long and stuck it on top of a standard stub using a conducting carbon pad, as used for mounting specimens. Before sticking these components together I drilled and tapped the Al cylinder with an M4 thread. An M4 cheese head stainless steel (non-magnetic) screw securely holds the filament legs, providing the required conducting path to the stage. This is shown in Figure 5.

Fig. 5: Simple jig for supporting the filament in the SEM chamber. In this photo it is supported, outside of the SEM in a stub carrier.
